## RESULTS OF INSTRUMENT OBSERVATIONS AND ADAPTIVE PREDICTION OF THERMOABRASION OF BANKS OF THE VILYUI RESERVOIR

Translated from *Gidrotekhnicheskoe Stroitel'stvo*, No. 6, June 2013, pp. 2 – 8.

Quantitative data derived from observations of reformation of the thermoabrasive banks of the Vilyui Reservoir in Yakutia during the service period from 1972 through 2011, and results of analytical prediction of bank formations over the next 20 years for purposes of monitoring the ecological safety of this water body are presented.

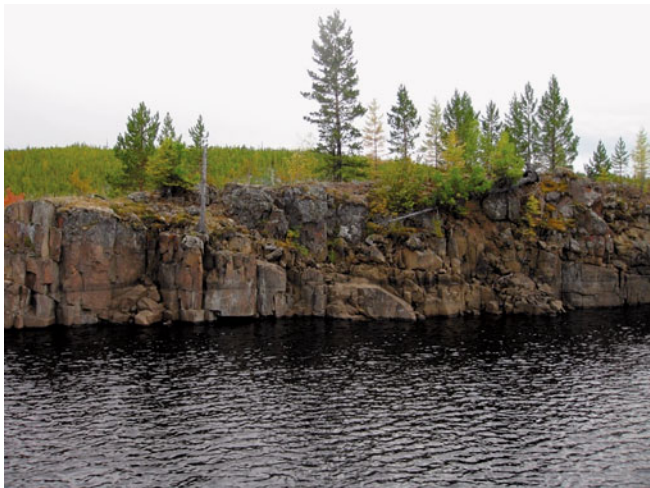
Fig. 1. Precipitous rock banks along Vilyui Reservoir in area of Kusagan “pipe.”

connects the Duran and Kusagan broadenings, as in the majority of narrowings along the entire reservoir, is a canyon 300 – 500 m wide, which cuts into the traprock plateau. The majority of the banks are steep with large-lump talus, and are frequently vertical. On the surface, the bedrocks (dolerites) are weathered, jointed, and weakly resistant to mechanical action (Fig. 1).

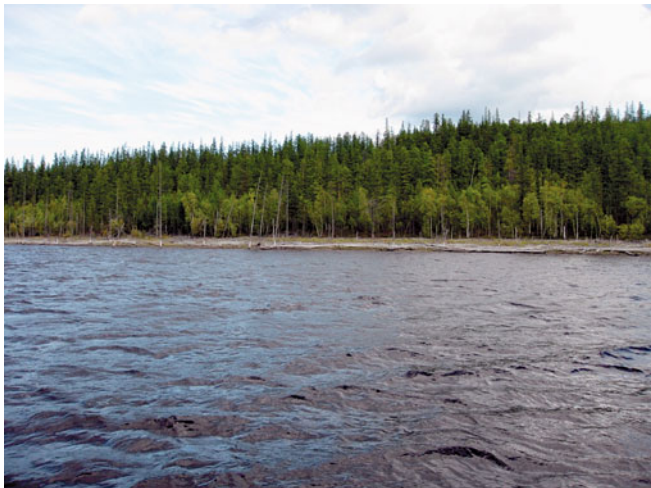
Fig. 2. Rock slopes of left bank in Dyraninskoe broadening of Vilyui Reservoir, which are covered by layer of Quaternary deposits.

Over a large portion of the length, the shore slopes of the reservoir in the zone of water-level fluctuation have thin Quaternary deposits of alluvial-deluvial origin, which are underlain by bedrocks (Fig. 2).

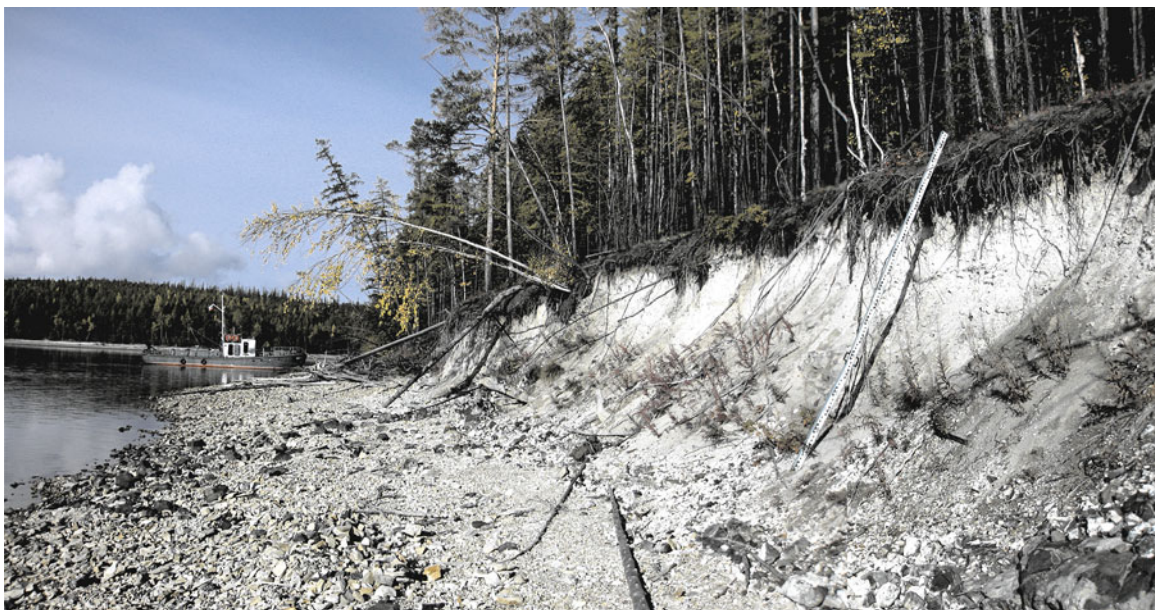
**Fig. 6.** Thermoabrasion right bank of Vilyui Reservoir at Section No. 6 in Kusagan broadening; bank is composed of fine sands.

Section No. 6. Located on the right bank of the Kusagan broadening near the “Kusagan” hydrometeorological station (Fig. 6). The bank with a northerly exposed slope and steepness of 1 – 6° is composed of fine alluvial sand, and is collapsing-crumbling thermoabrasion. The wave energy is 247, 960 kJ/year per running meter. Bank profiles were measured with respect to five cross sections. The results are presented in Fig. 7 and Table 4.

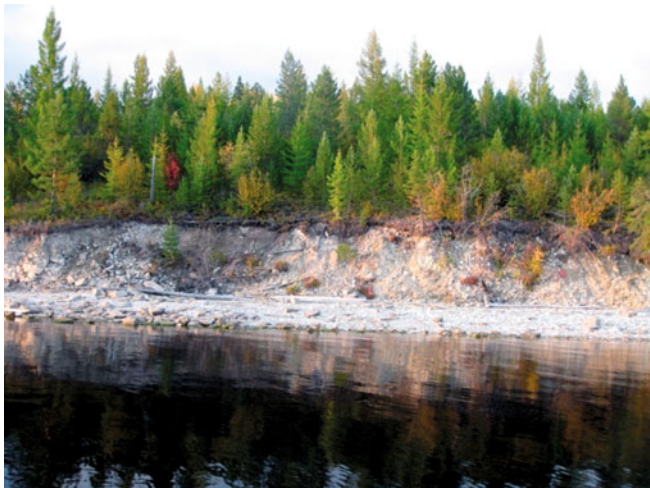
Fig. 8. Thermoabrasion right bank of Vilyui Reservoir in Section No. 7 near mouth of Ust'-Chon "pipe" composed of highly weath-

Section No. 7. Located on the right bank of the reservoir near the mouth of the Ust'-Chon “pipe” (Fig. 8). The slope has a southwestern exposure and its steepness increases from 5 to 11° from south to north. The bank is composed of highly weathered limestones and sandstones (Ordovician carbonate rocks), and is collapsing-lumpy and thermoabrasion. In the section, there is one observation site, data from which are presented in Fig. 9 and Table 5.
